Safety Inspection Report

Annual Inspection

Bradley Playground

08 September 2026

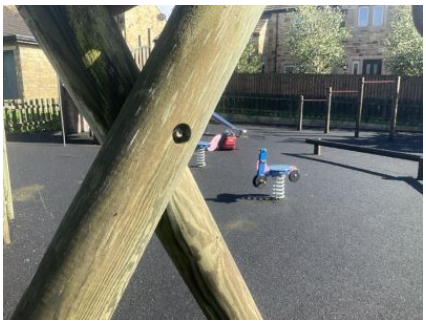
Cap missing.

Replace.

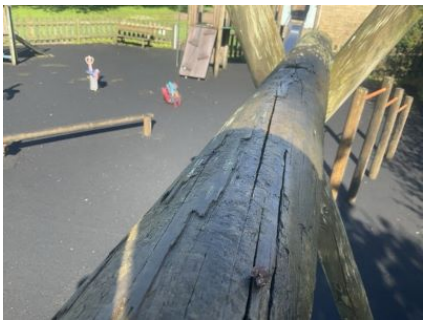
There are natural splits / shakes in the timbers.

Monitor for decay forming within the shakes on the crossbar.

DO NOT fill shakes. There are shakes running through fixing points. Ensure the fixings are fully secure on regular basis.
